Appendix F1 – Assessment of Controls (Watershed Restoration Assessment)

**WHEEL CREEK
WATER CHEMISTRY MONITORING
YEAR 11 REPORT**

Final, December 8, 2021

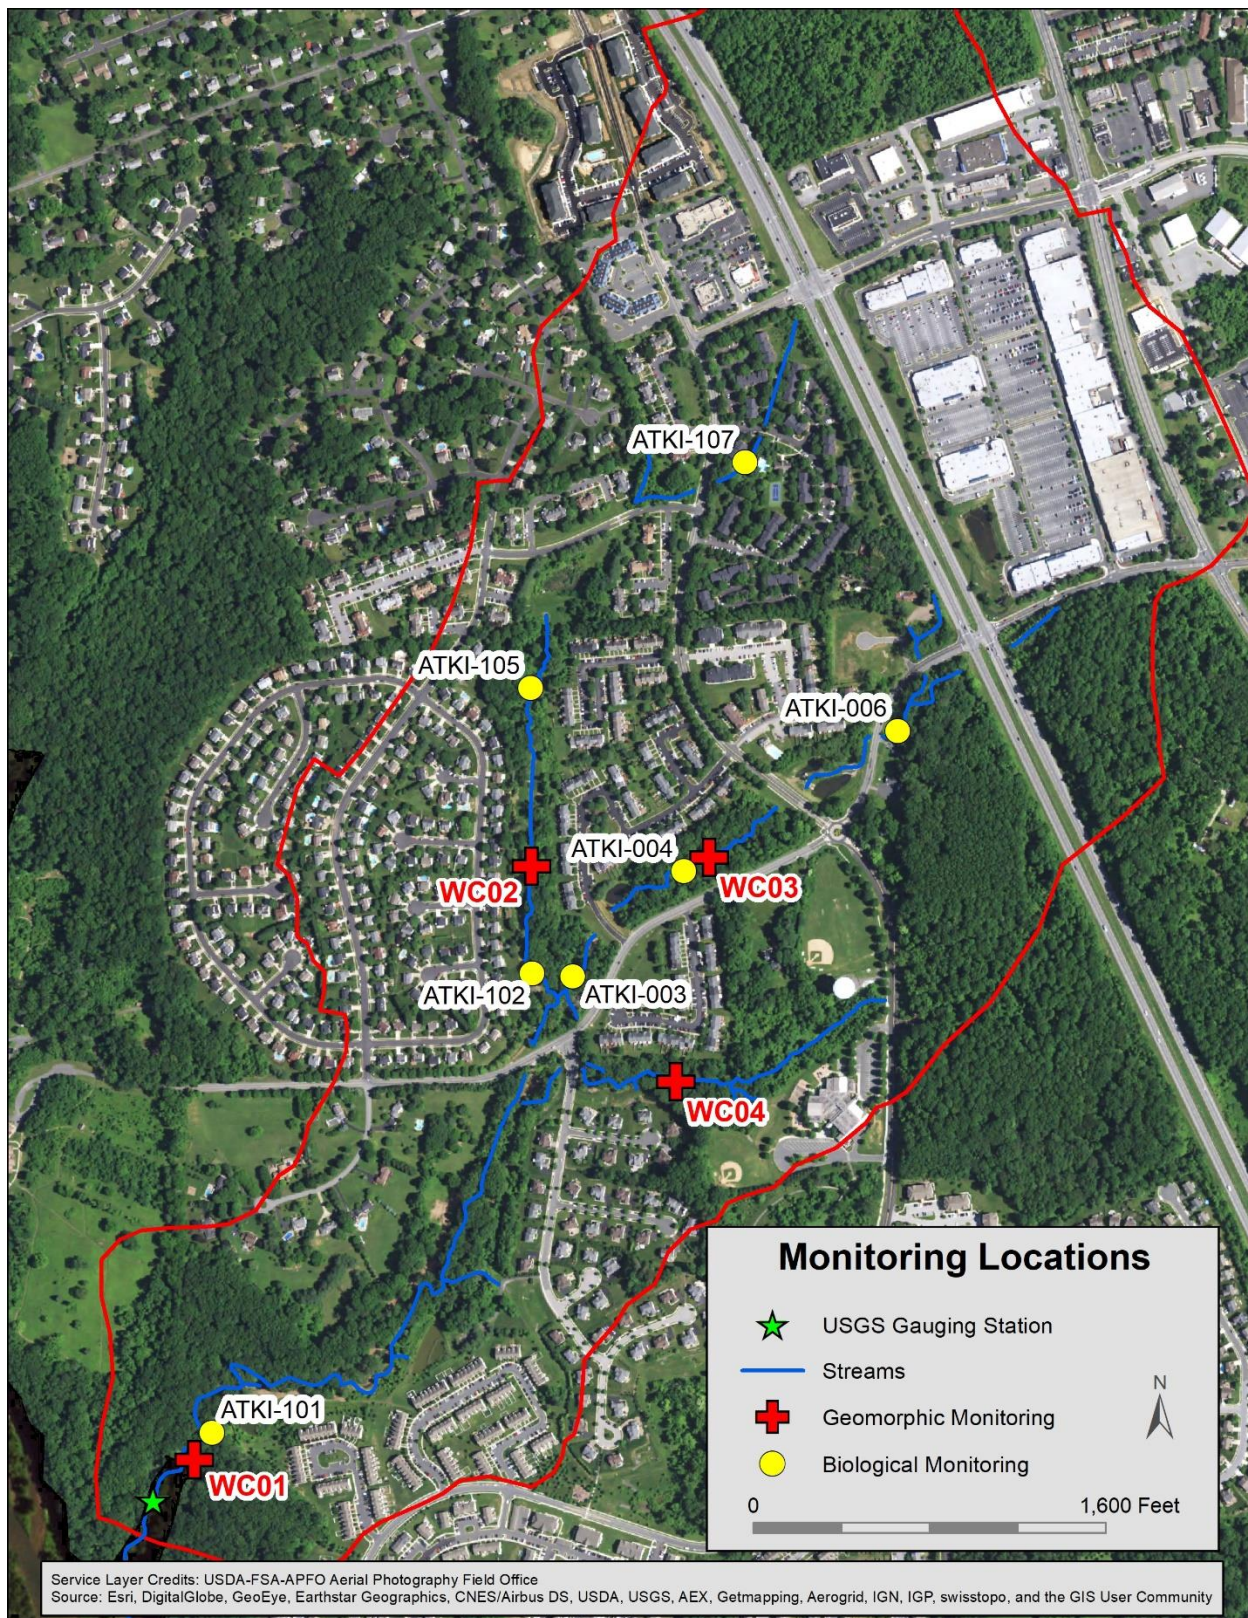
Figure 2-1. Wheel Creek monitoring locations

KCI installed and surveyed three (3) benchmark monuments at each reach during the initial baseline monitoring effort (2010) to establish consistent survey elevations from year to year, as well as start and end points for each survey reach. Two benchmarks (one concrete monument and one capped iron rebar pin) were placed on either side of the channel, whereby a measuring tape run from the left bank pin to the right bank monument marks the starting point (i.e., station 0+00) in the channel for the longitudinal profile. The concrete monument was set in 2-inch PVC piping to a depth of 30 inches, with a rounded stove bolt set in the concrete to establish the monumented benchmark elevation, which will be used to compare longitudinal profiles over time. A third monument (capped iron rebar) was placed at the upstream end of the reach to mark the end of the survey reach. Versar re-surveyed these benchmarks at WC03 and WC04 during the Post-Restoration Years 1, 2, 3, and 4 efforts to enable overlays between past surveys.

Versar re-established reaches WC01 and WC02 in 2017 for Post-Restoration Year 1 monitoring. Three (3) benchmark monuments were again installed at both reaches. Two capped iron rebar monuments were installed on each side of the channel to mark the starting point of the new longitudinal profile (i.e., station 0+00). An additional capped iron rebar monument was installed upstream marking the end of the longitudinal profile. These were re-surveyed in 2018, 2019, and 2020.
